Navajo Abandoned Uranium Mine

Site Screen Report

Mel Gardner AUM Site

January 2011

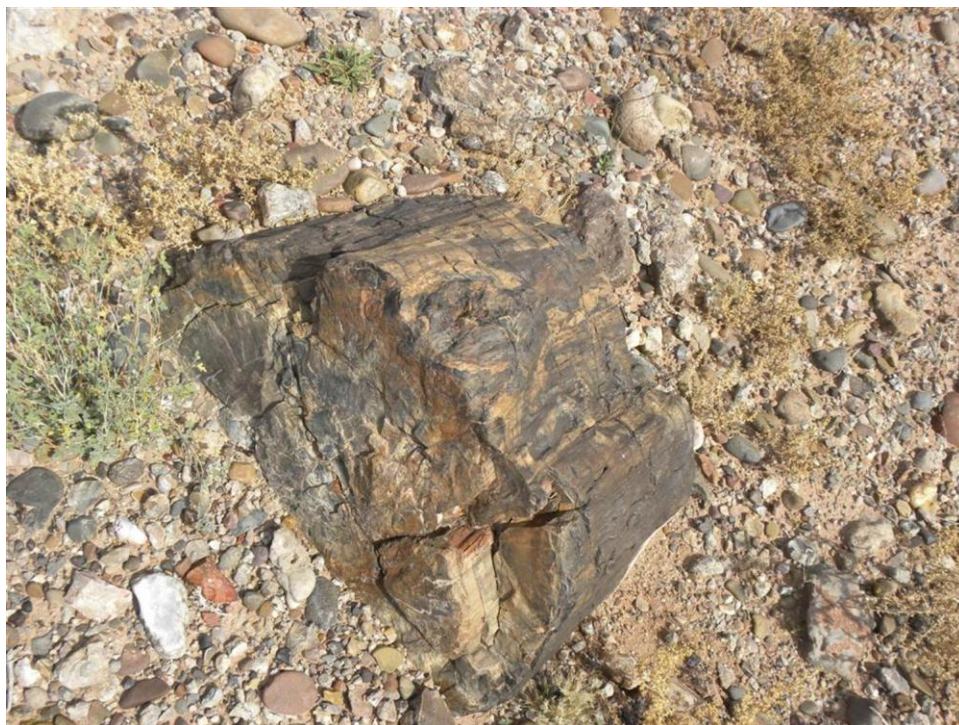
A total of 857 gamma radiation measurements were collected from the mine site, ranging from 8,925 cpm to 78,011 cpm. The measurements collected at an isolated piece of petrified wood were found at a maximum level of approximately 75,000 cpm. The measurements are represented in Figures 1 and 2.

Photo 3. Mel Gardner mine site, petrified wood, with elevated gamma readings

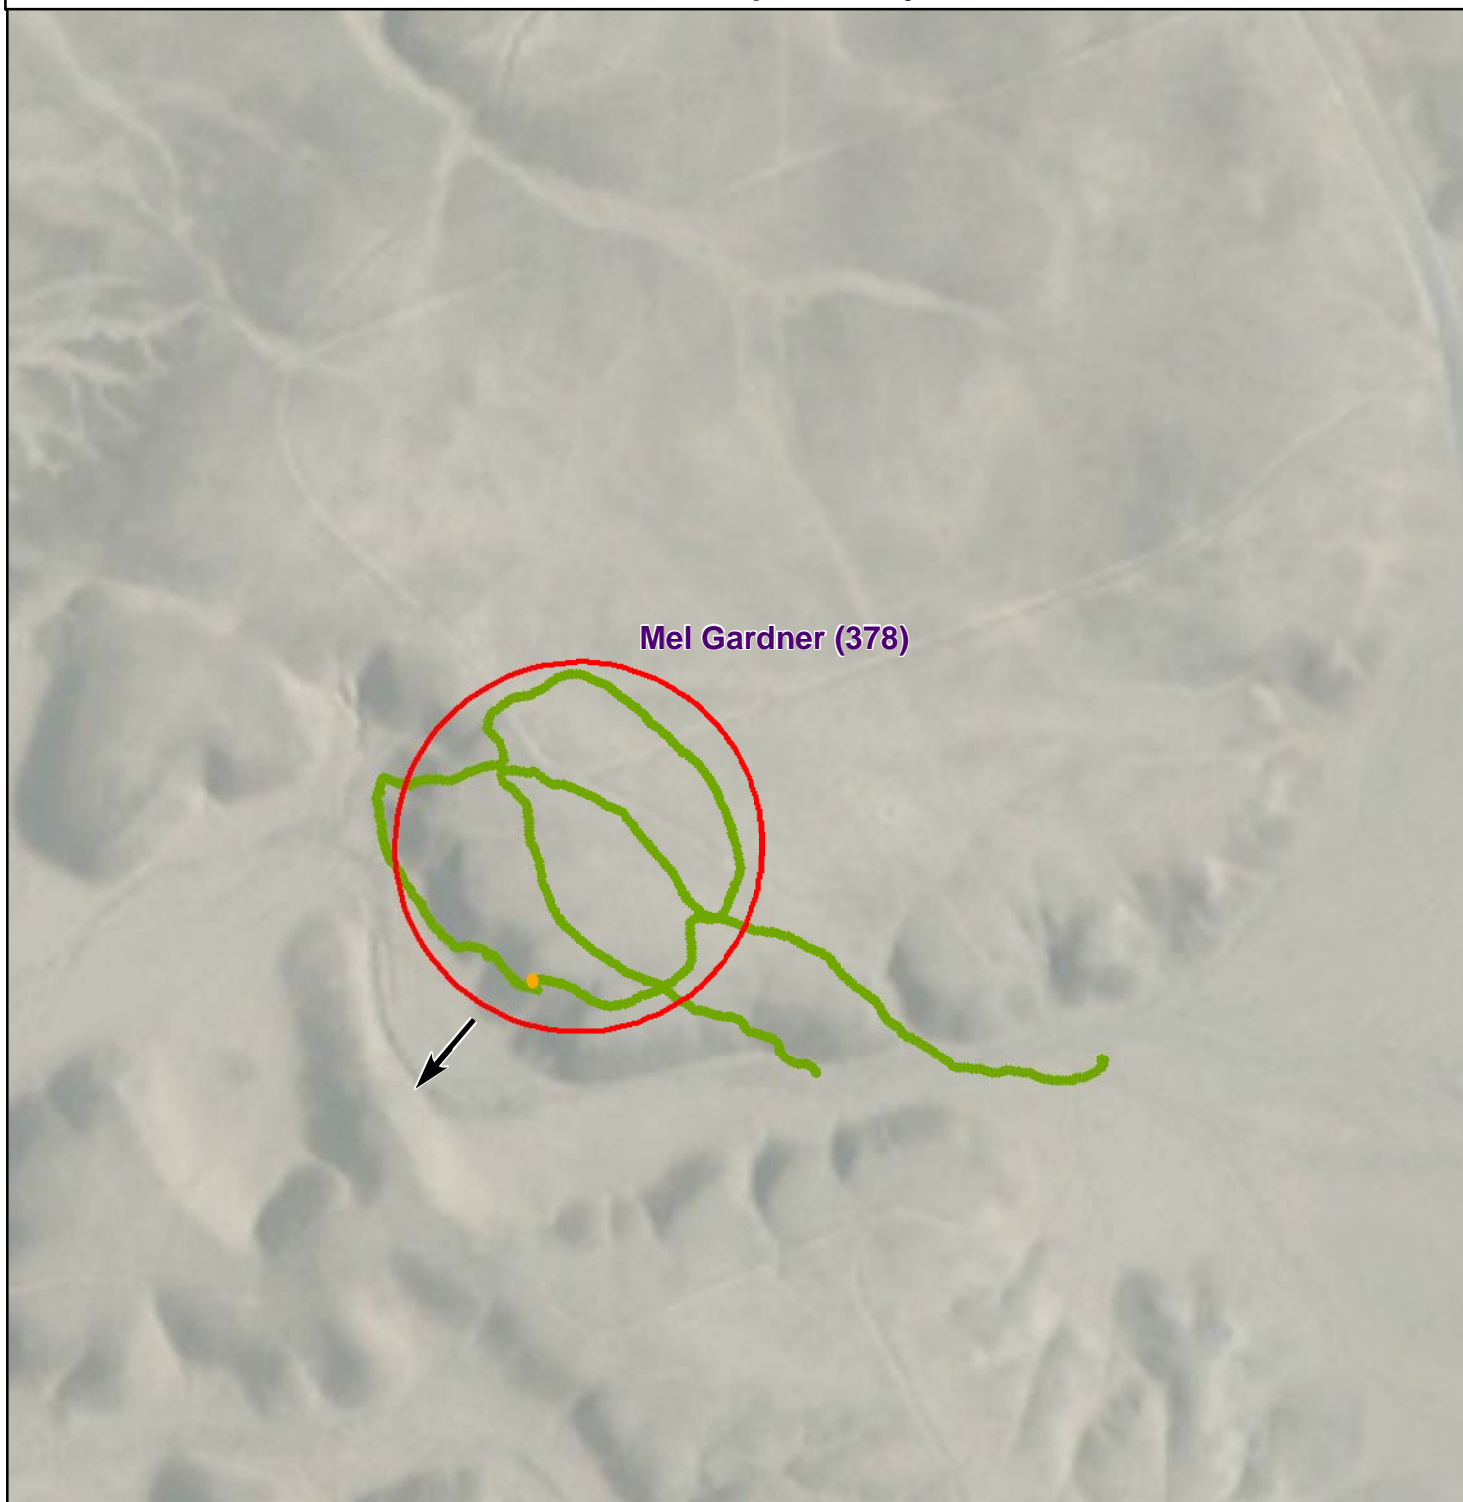
**Figure 1 - Gamma Radiation Measurements, Above Two Times
Mel Gardner (378)
Coalmine Mesa Chapter, Navajo Nation**

Gamma survey conducted 11/2010
Measured as counts per minute (cpm)

Average background 10,540 cpm

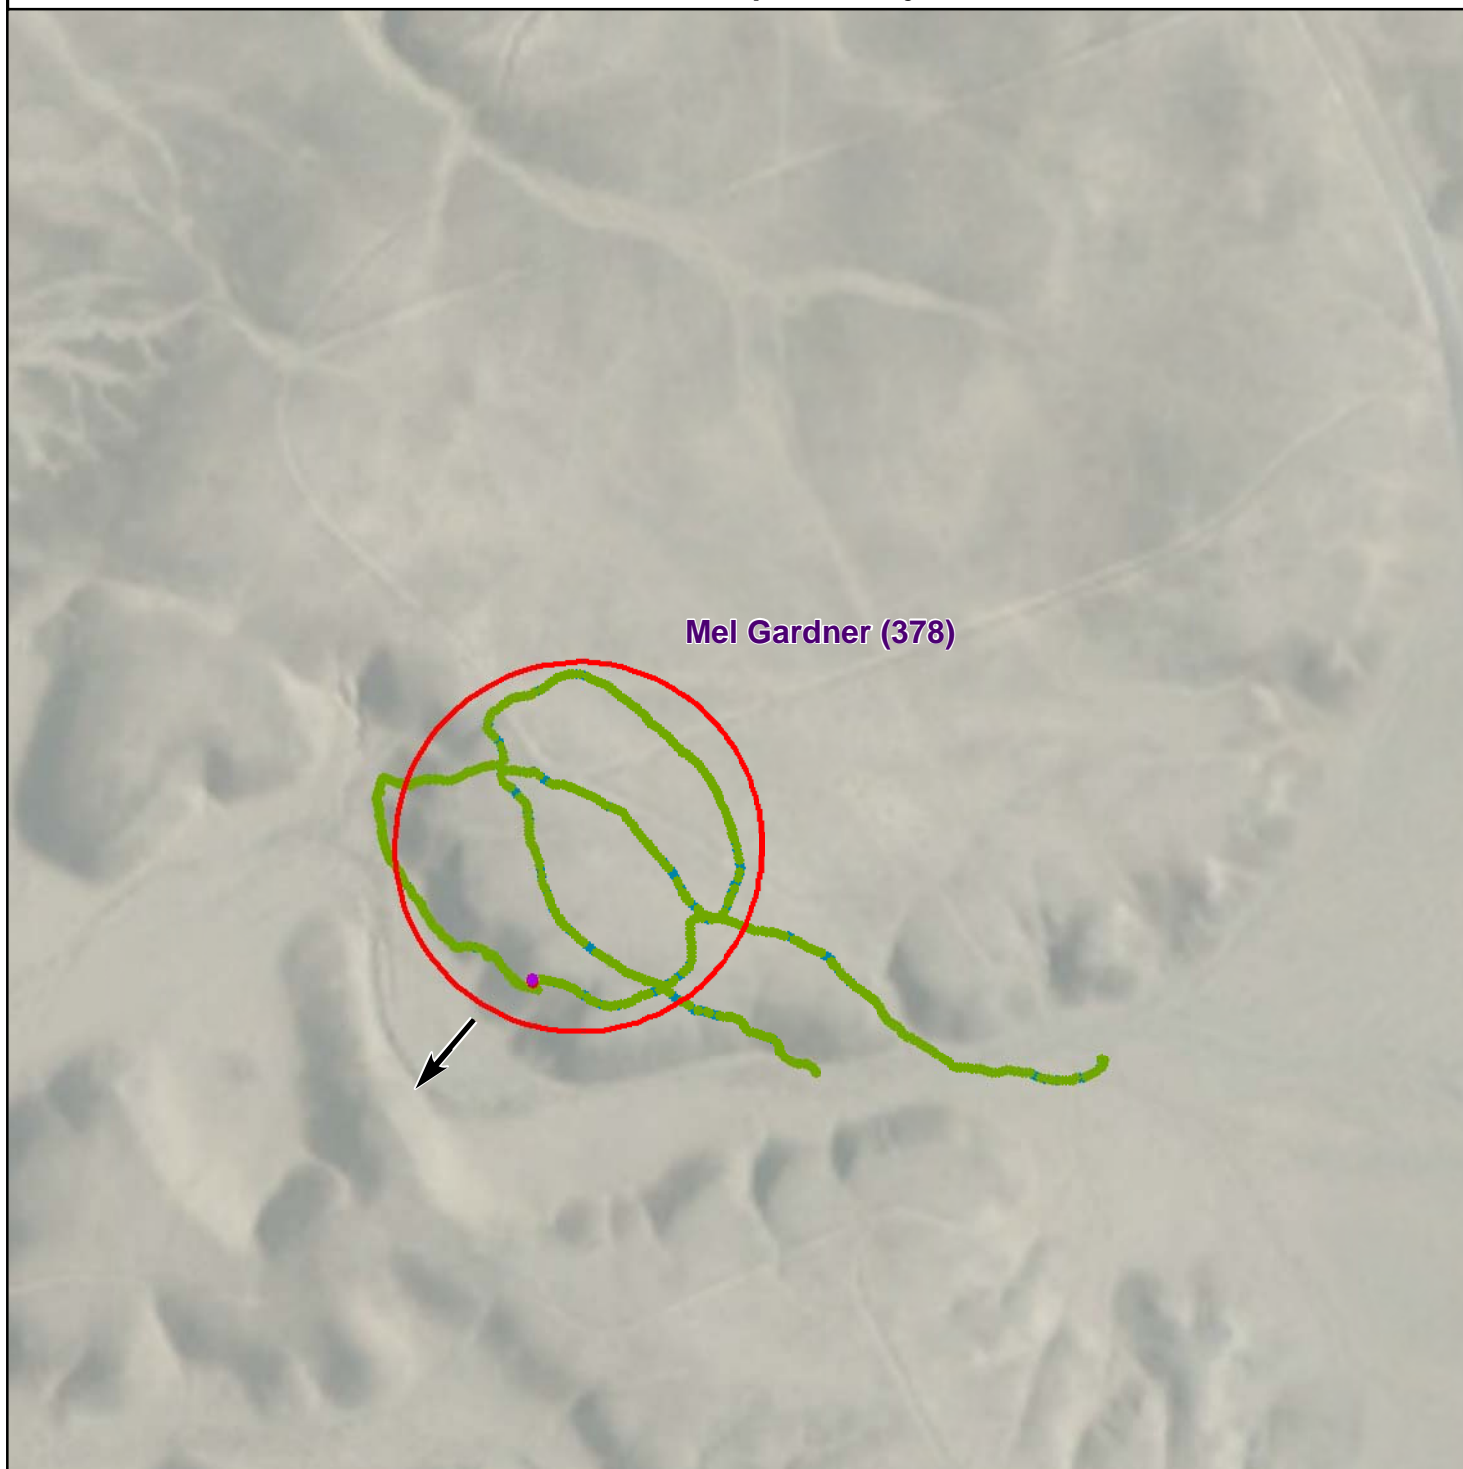
Figure 2 - Gamma Radiation Measurements
Mel Gardner (378)
Coalmine Mesa Chapter, Navajo Nation

Gamma survey conducted 11/2010
Measured as counts per minute (cpm)

Average background 10,540 cpm
